**Flood Control Project Maintenance
Levee Inspections**

Fall 2016 Levee Maintenance Deficiency Summary Report

Reclamation District No. 0341 Sherman Island

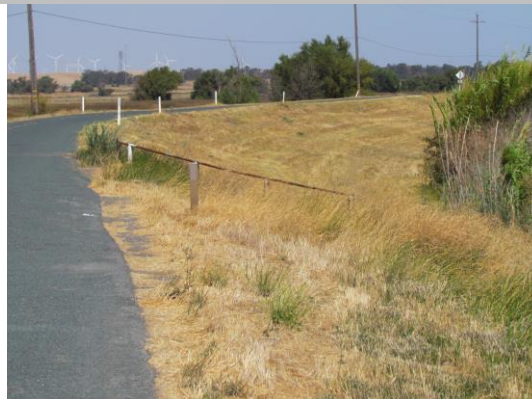
Photo 1 of 1 : FA_2016_RD0341_167_20_20160928_00048.jpg

LM Start	0.00	Rating **	M	Issue No.	20
LM End	0.03	Issue Type +	Ma	Location *	WS
Category	Earthen Levee			GPS Latitude/Longitude	
				Start	End
Item	Vegetation			38.085555 °	38.085918 °
				-121.686438 °	-121.686690 °
DWR ID	DWR_RD0341_01_f_2016_20				
Comment Code					
V1 : Control annual grass and weeds on the levee slopes and easements.					
Inspector Comment					
Control the regrowth on the waterside..

RD 341 Looking downstream from waterside.

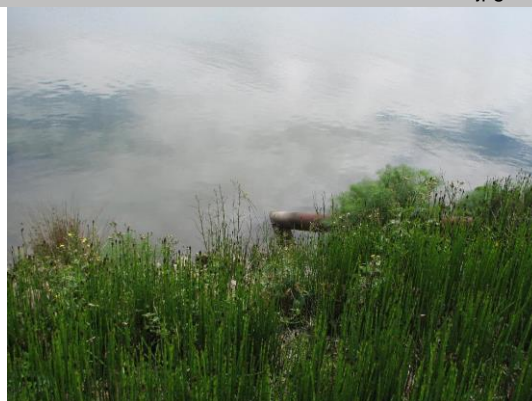
Photo 2 of 2 : UCIP_FA_2016_22068_37658.jpg

FS_ID:22068
DS_ID:24111
EP_NO: 1477
Repair Type: Non-Urgent
Crossing Status: Found
UCIP Comments: Dense vegetation limits the inspector's visibility to identify signs of pipe failure (leaks) along the slopes. Recommend removing vegetation along pipe alignment to conduct proper inspection of structure and appurtenances.
FIELD_STRUCT_DESC: 10-inch steel pipe through the levee, 1.8 feet below the crown. Pipe is encased in 12-inch CM conductor pipe under crown. Pump on landward side. Air vent and metal distribution box with gate on the landward side. Rock revetment on the waterward slope. (USACE-1962). This entry matches the Drainage or Irrigation Structure referenced in O&M manual (HLM 0.50). 30-feet of pipe under crown was replaced and encased in CM pipe under Permit No. 1477 (1950). FS Date: 5/5/2009

Cut along pipe alignment--unknown repair or maintenance date.

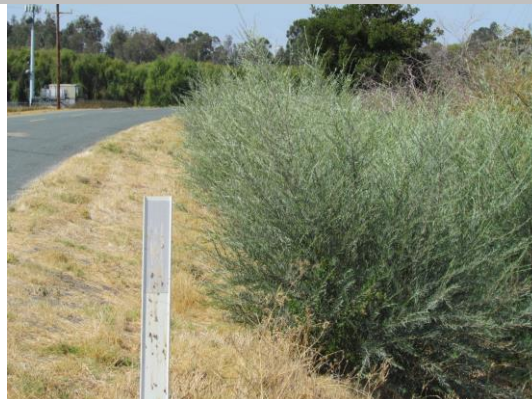
Photo 1 of 1 : FA_2016_RD0341_167_24_20160928_00049.jpg

LM Start	3.00	Rating **	U	Issue No.	24
LM End	3.10	Issue Type +	Ma	Location *	WS
Category	Earthen Levee			GPS Latitude/Longitude	
				Start	End
Item	Vegetation			38.104035 °	38.104092 °
				-121.696222 °	-121.698138 °
DWR ID	DWR_RD0341_01_f_2016_24				
Comment Code					
V2 : Remove the wild growth other than native grasses from the levee slopes.					
Inspector Comment					
These small willow trees can be sprayed.

RD 341 looking downstream from levee mile 3.00-3.10 waterside slope.

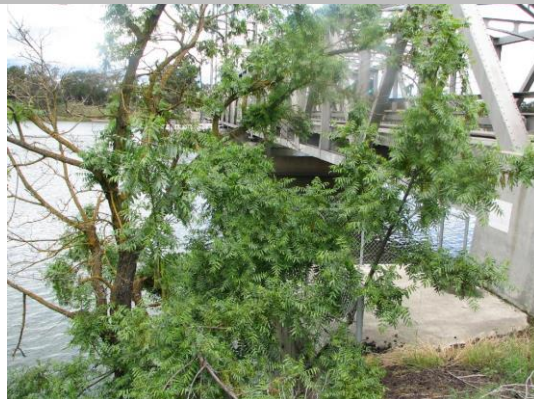
Photo 1 of 2 : UCIP_FA_2016_22183_37780.jpg

View of waterward side.

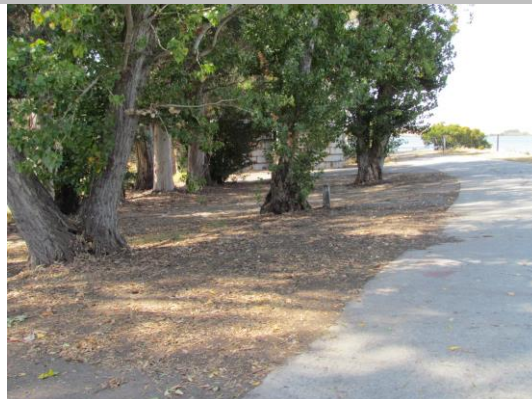
Photo 1 of 1 : FA_2016_RD0341_168_36_20160928_00074.jpg

LM Start	3.36	Rating **	A	Issue No.	36
LM End	3.95	Issue Type +	Ma	Location *	LS
Category	Earthen Levee			GPS Latitude/Longitude	
				Start	End
Item	Vegetation			38.105270 °	38.098012 °
				-121.702528 °	-121.706290 °
DWR ID	DWR_RD0341_02_f_2016_36				
Comment Code					
V1 : Control annual grass and weeds on the levee slopes and easements.					
Inspector Comment					
No unwanted vegetation from levee miles 3.36-3.95 landside.

RD 341 Looking downstream from levee miles 3.36-3.95.

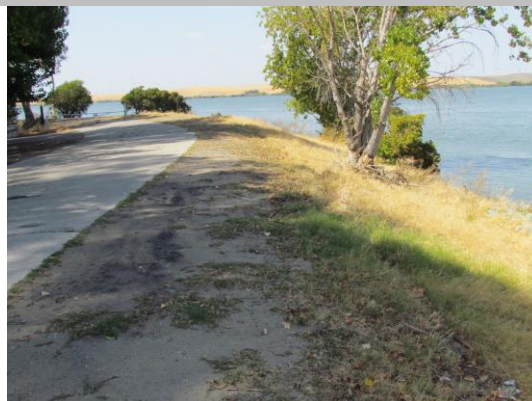
Photo 1 of 1 : FA_2016_RD0341_168_35_20160928_00073.jpg

LM Start	3.36	Rating **	A	Issue No.	35
LM End	3.97	Issue Type +	Ma	Location *	WS
Category	Earthen Levee			GPS Latitude/Longitude	
				Start	End
Item	Vegetation			38.105270 °	38.097763 °
				-121.702528 °	-121.706290 °
DWR ID	DWR_RD0341_02_f_2016_35				
Comment Code					
V1 : Control annual grass and weeds on the levee slopes and easements.					
Inspector Comment					
Waterside slope levee mile 3.36-3.97 no unwanted vegetation.

RD 341 Looking downstream from the waterside slope levee miles 3.36-3.97.

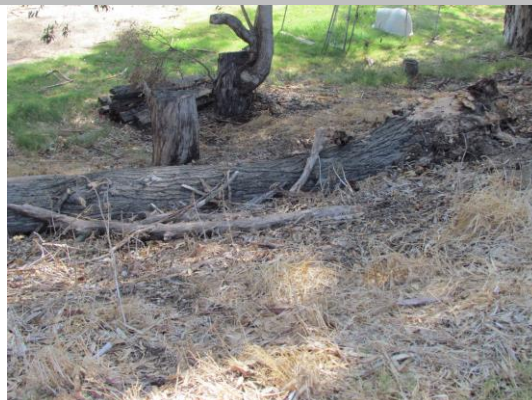
Photo 1 of 1 : FA_2016_RD0341_168_37_20160928_00075.jpg

LM Start	3.45	Rating **	M	Issue No.	37
LM End	3.45	Issue Type +	En	Location *	LS
Category	Earthen Levee			GPS Latitude/Longitude	
				Start	End
Item	Encroachments			38.104785 °	38.104785 °
				-121.704013 °	-121.704013 °
DWR ID	DWR_RD0341_02_f_2016_37				
Comment Code					
TR : Tree or limb					
Inspector Comment					
Remove the dead fallen tree from the landside slope.

RD 341 landside levee mile 3.45.

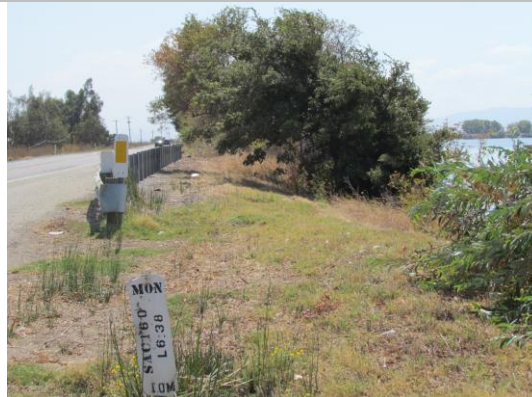
Photo 1 of 1 : FA_2016_RD0341_168_45_20160928_00082.jpg

LM Start	3.97	Rating **	U	Issue No.	45
LM End	6.19	Issue Type +	Ma	Location *	WS
Category	Earthen Levee			GPS Latitude/Longitude	
				Start	End
Item	Vegetation			38.097763 °	38.080573 °
				-121.706288 °	-121.731113 °
DWR ID	DWR_RD0341_02_f_2015_45				
Comment Code					
V2 : Remove the wild growth other than native grasses from the levee slopes.					
Inspector Comment					
The unwanted vegetation on the waterside slope need to be removed.

RD 341 Unit 2 looking downstream from the waterside levee slope levee mile 3.97-6.19.

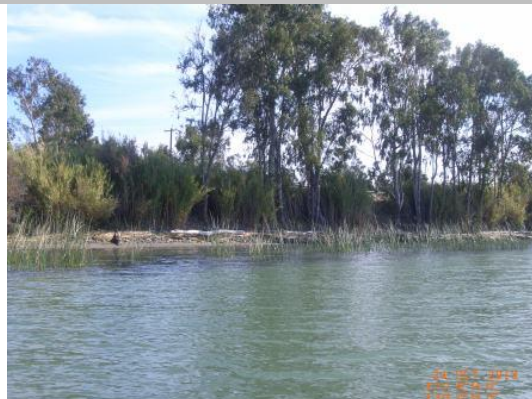
Photo 1 of 1 : FA_2016_RD0341_168_7_20160913_00004.jpg

LM Start	4.15	Rating **	M	Issue No.	7
LM End	4.19	Issue Type +	Ma	Location *	WS
Category	Supplemental			GPS Latitude/Longitude	
				Start	End
Item	2015 USACE Erosion Survey, DRAFT			38.095148 °	38.094590 °
				-121.706367 °	-121.706393 °
DWR ID	DWR_RD0341_02_s_2016_7				
Comment Code					
Inspector Comment					
2011 - Large new erosion pocket probably hidden by vegetation in the past. 2015: No observed changes. [2015 Site ID: SAC_8-2_L]

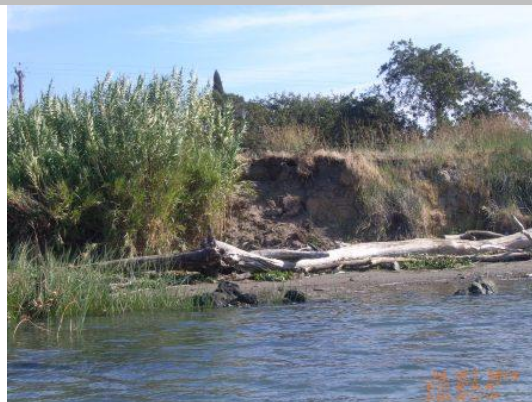
Photo 1 of 1 : FA_2016_RD0341_168_3_20160913_00002.jpg

LM Start	4.47	Rating **	U	Issue No.	3
LM End	4.62	Issue Type +	Ma	Location *	WS
Category	Supplemental			GPS Latitude/Longitude	
				Start	End
Item	2015 USACE Erosion Survey, DRAFT			38.090620 °	38.088572 °
				-121.706684 °	-121.707127 °
DWR ID	DWR_RD0341_02_s_2016_3				
Comment Code					
Inspector Comment					
1999 - New small slump in eroded bank. 2005 - Reach extended because of vertical bank along the roadway upstream. 2011 - More slumping since last year. 2012 - Site upgraded to critical. Very steep slope which may be effecting the highway on top of the levee. 2015: New erosion towards downstream end of site. [2015 Site ID: SAC_8-0_L]

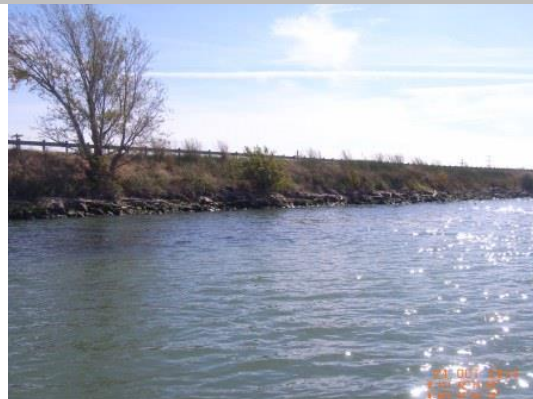
Photo 1 of 1 : FA_2016_RD0341_168_4_20160913_00003.jpg

LM Start	4.76	Rating **	U	Issue No.	4
LM End	4.85	Issue Type +	Ma	Location *	WS
Category	Supplemental			GPS Latitude/Longitude	
				Start	End
Item	2015 USACE Erosion Survey, DRAFT			38.086603 °	38.085459 °
				-121.707786 °	-121.708607 °
DWR ID	DWR_RD0341_02_s_2016_4				
Comment Code					
Inspector Comment					
2011 - Large slump section. 2012 - Site extended downstream, upgraded to critical, severe windwave. Slope is very steep and may be effecting the highway on top of the levee. 2015: No observed changes. [2015 Site ID: SAC_7-9_L]

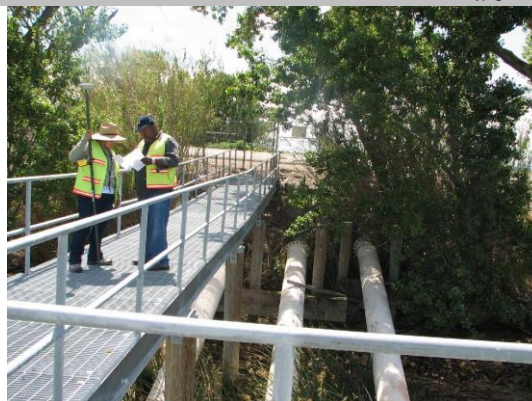
Photo 1 of 2 : UCIP_FA_2016_22253_37885.jpg

Pipes, walkway, fence, and support piles located on waterward side.

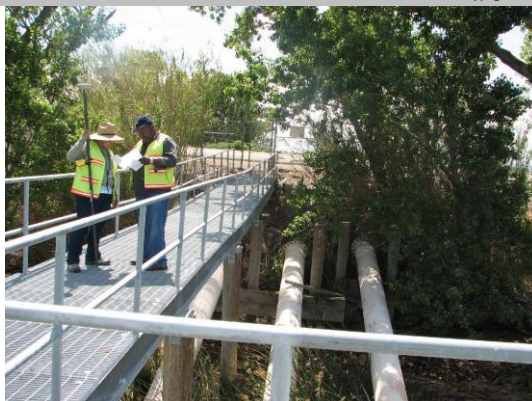
Photo 1 of 2 : UCIP_FA_2016_22254_37896.jpg

Pipes, walkway, fence, and support piles located on waterward side.

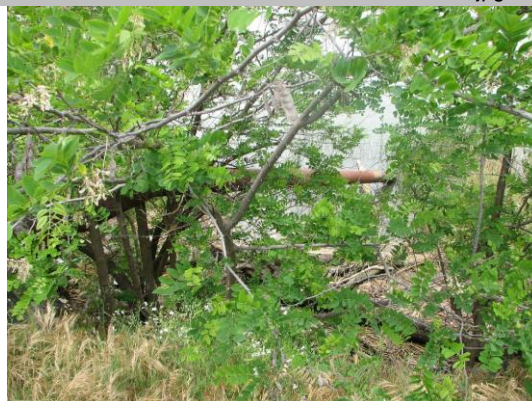
Photo 2 of 2 : UCIP_FA_2016_22256_37914.jpg

View of pipe through brush on waterward side.

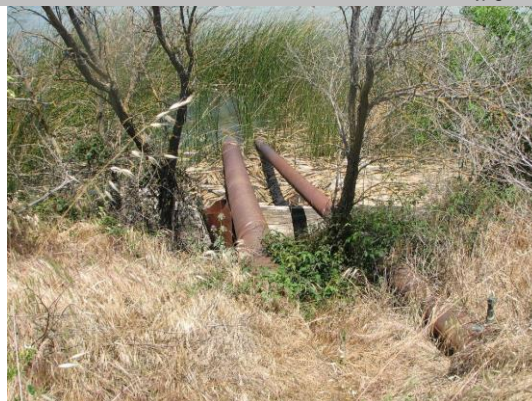
Photo 1 of 2 : UCIP_FA_2016_22259_37935.jpg

View of pipes on waterward side.

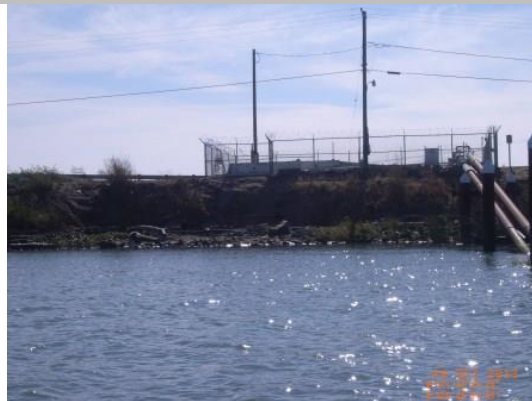
Photo 1 of 1 : FA_2016_RD0341_168_1_20160913_00001.jpg

LM Start	6.03	Rating **	U	Issue No.	1
LM End	6.16	Issue Type +	Ma	Location *	WS
Category	Supplemental			GPS Latitude/Longitude	
				Start	End
Item	2015 USACE Erosion Survey, DRAFT			38.080370 °	38.080526 °
				-121.728341 °	-121.730483 °
DWR ID	DWR_RD0341_02_s_2016_1				
Comment Code					
Inspector Comment					
2011 - Large slump at downstream end. Gully formed from surface runoff from the road. Shallow slumping throughout site. 2012 - The gully at upstream end has increased in size and site continues to worsen. 2015: No observed changes. [2015 Site ID: SAC_7-3_L]

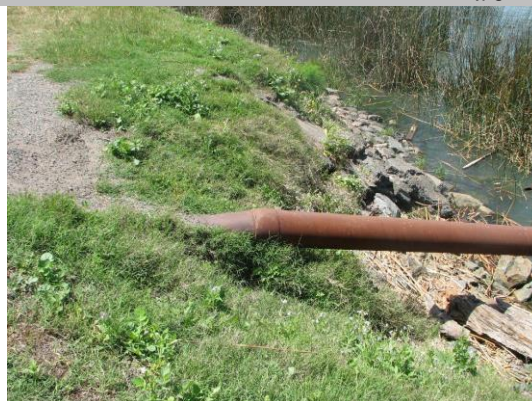
Photo 1 of 2 : UCIP_FA_2016_22261_37949.jpg

Side view of pipe on waterward side.

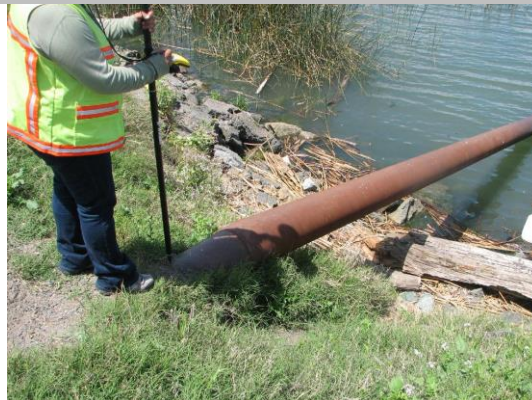
Photo 2 of 2 : UCIP_FA_2016_22261_37947.jpg

View of pipe and rip rap on waterward side.

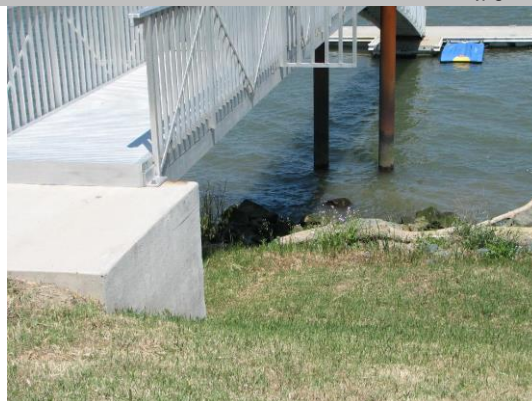
Photo 1 of 2 : UCIP_FA_2016_22303_38062.jpg

View of waterward side. Conduit goes through concrete structure connecting walkway.

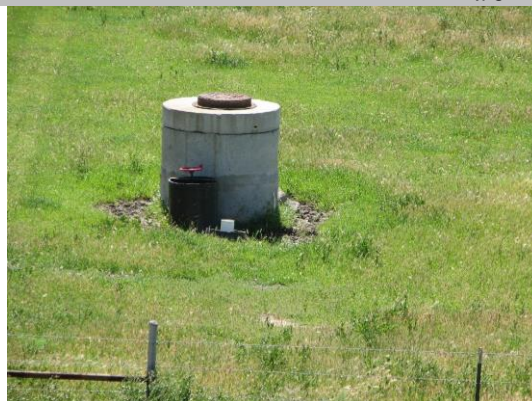
Photo 1 of 2 : UCIP_FA_2016_22309_38075.jpg

Concrete stand pipe and gate valve located on landward side.
